NACA TN No. 1531

TECHNICAL NOTE

A METALLURGICAL INVESTIGATION OF FIVE FORGED GAS-TURBINE  
DISCS OF TIMKEN ALLOY

By J. W. Freeman, E. E. Reynolds, and A. E. White

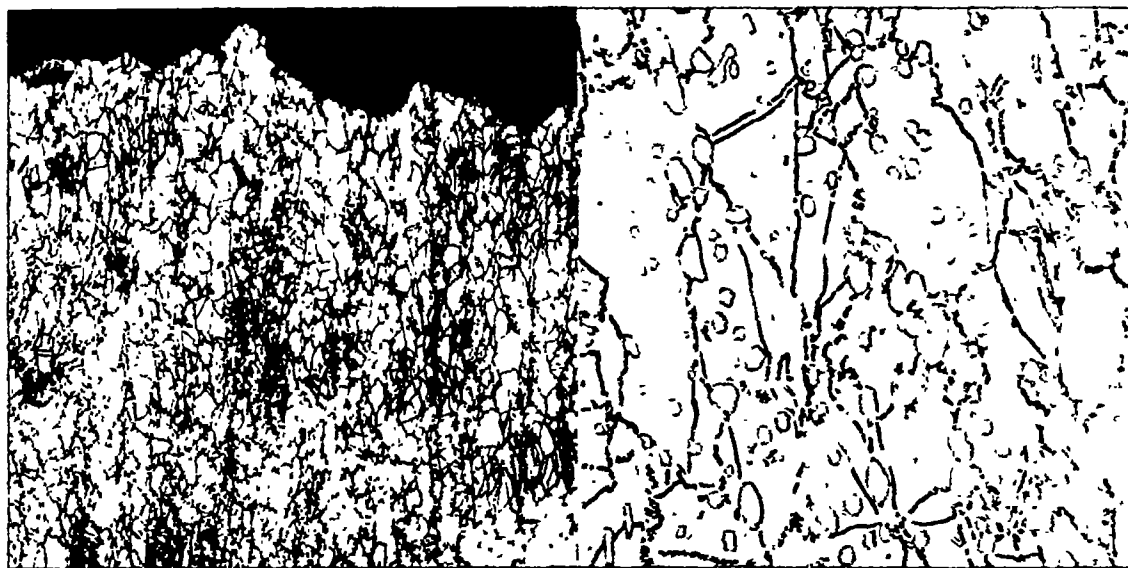
100X 1000X  
(a) Creep specimen 3Y; 1002 hours under 25,000 psi.

Fracture - 100X Interior - 1000X  
(b) Rupture specimen 2Y; 424 hours for rupture under 35,000 psi.

Figure 27.- Microstructures of completed 1200° F creep- and rupture-test specimens from disc H-4174-7A of Timken alloy.

During testing a tremendous amount of precipitation occurred in the three small discs. (See figs. 21, 23, and 25.) The solution-treated and hot-cold-worked disc, C3B-441, had a heavier but finer precipitate than the other two. The two large discs showed comparatively little precipitation during testing. (See figs. 27 and 29.)
